# BOILER GENERATING BANK INSPECTIONS

# ***Carbon Steel Tube Inspection Using Remote Field Electromagnetic Technique***

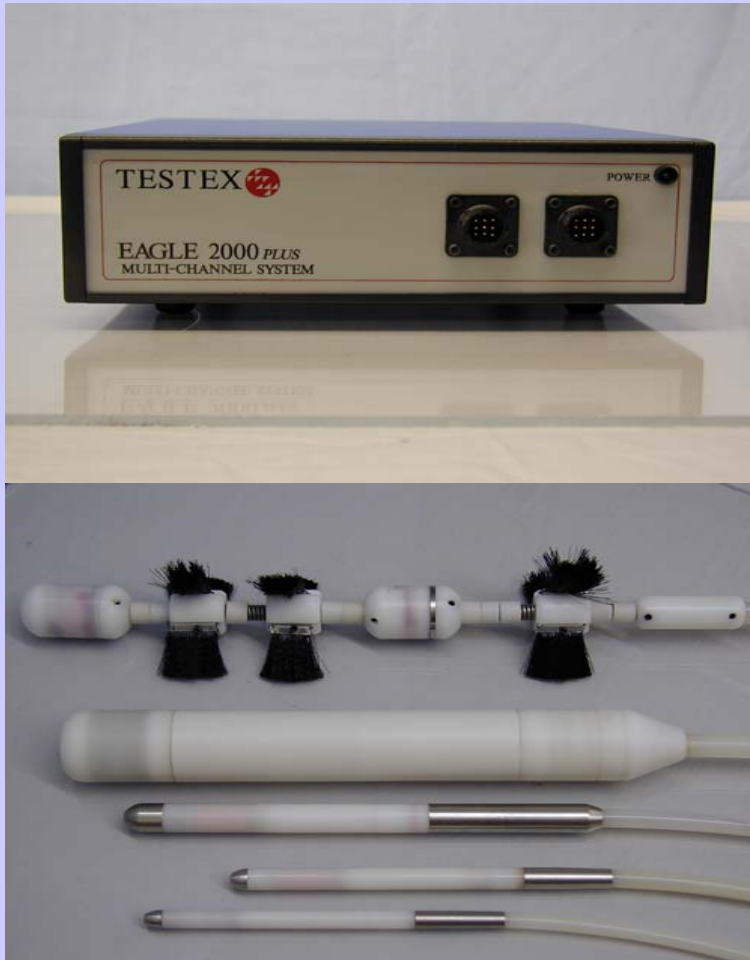
## **Eagle 2000 Plus System**

- ***Single/ Multi-channel System: Up to 8 Channels for tube inspection***
- ***300 to 350 tubes can be inspected in a 10 hour shift***
- ***Special Flexible Probes for boiler drum to drum tubes inspection***
- ***Flexible probe sizes can be built to inspect generating bank tubes ranging in size from 1" OD to 3.5" OD.***

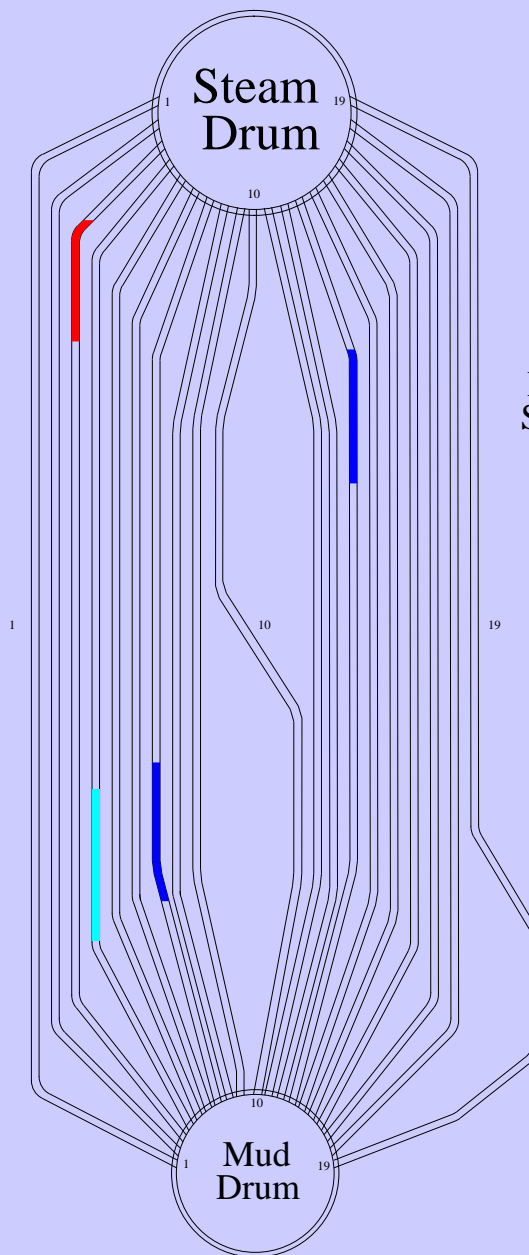
Column # 49

*Color Coded Side Elevation Diagram showing the location of the thinning.*

Cold Side

Hot Side

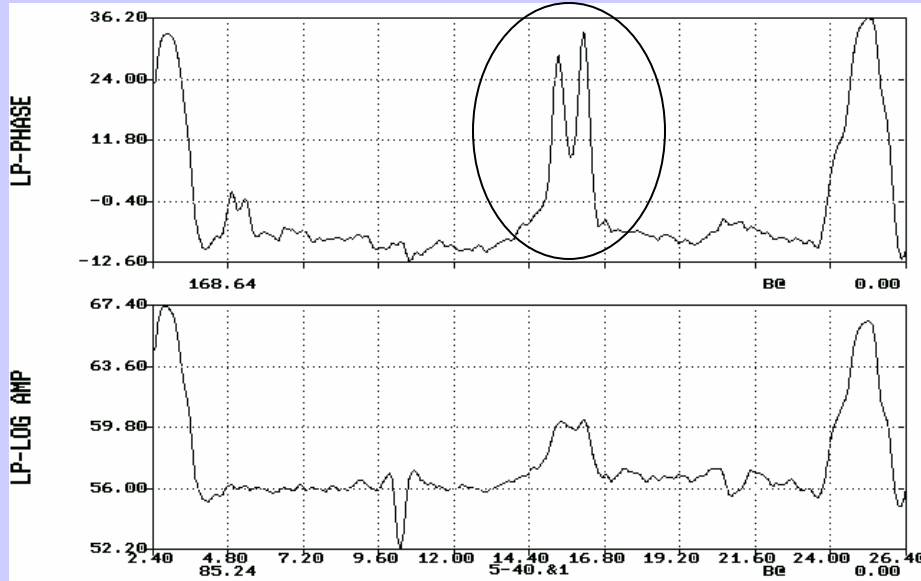
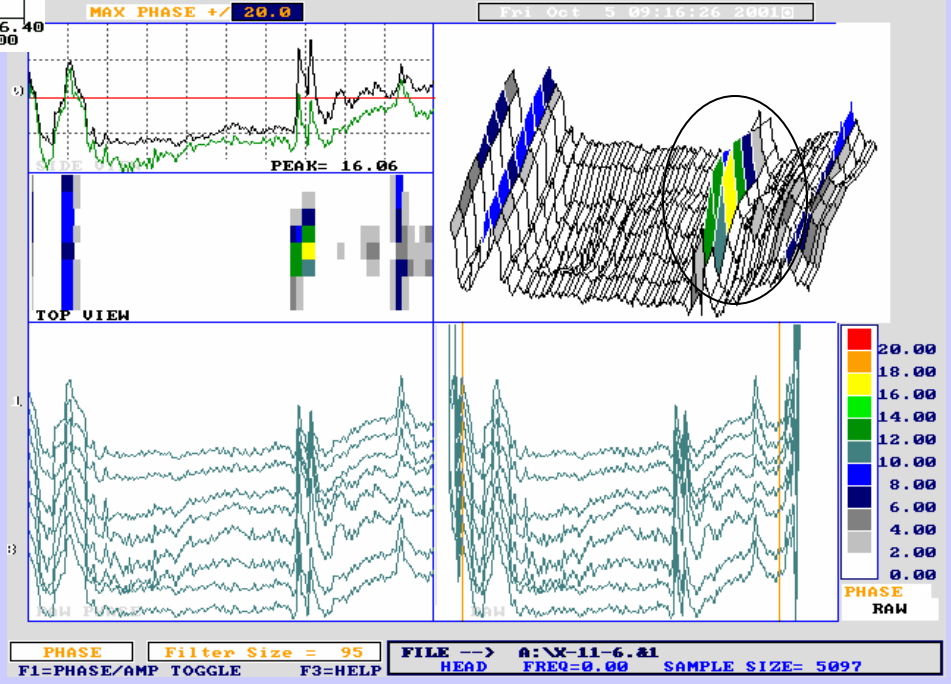
Single Channel and Multichannel Data showing 65-70% localized wall loss.

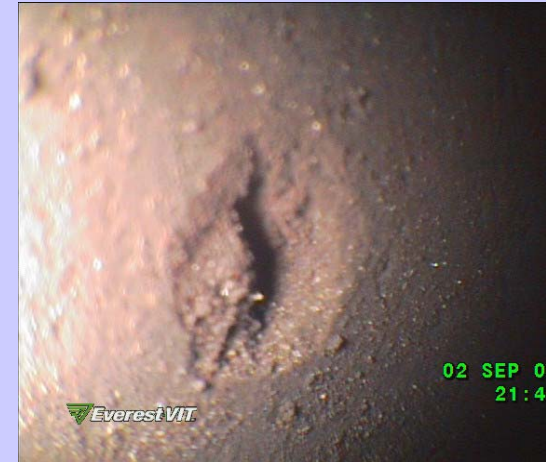
Example of ID pit found with Multichannel RFET Probe found between the mud drum and the mud drum bend.  
Carbon Steel 2.5" O.D., 0.165" tube swaged to 2" O.D.
